EVT 38-87-3
MIL-STD-1660 ENGINEERING TEST
OF

48" X 40" STANDARD METAL PALLET USING REVERSE LIGHTENING HOLES AND METAL TOP LIFT

REPORT NO. EVT 38-87-3

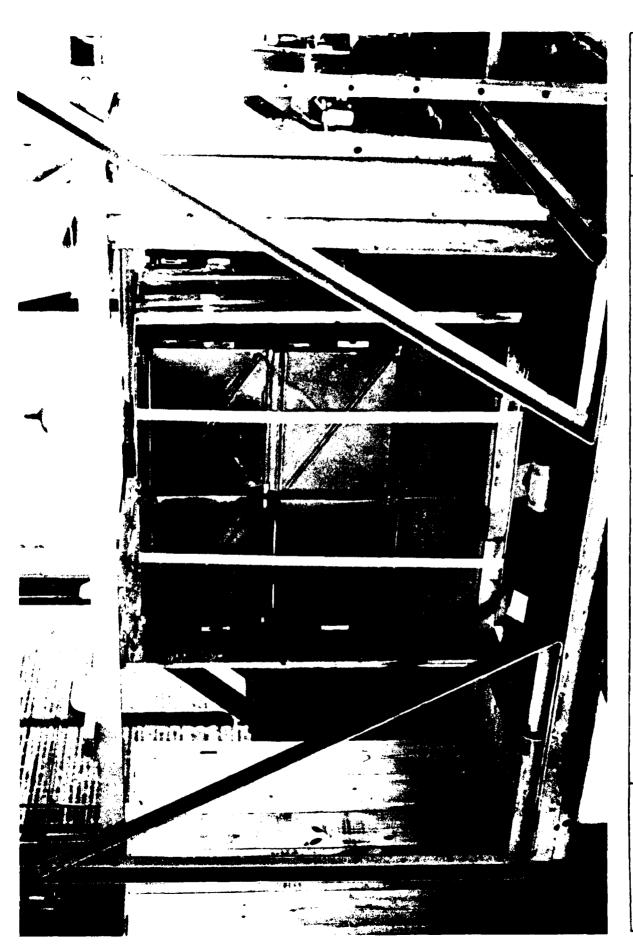
This photo shows the M548 cans and pallet in the Transportation Simulator in the Lateral Orientation. Photo 2.

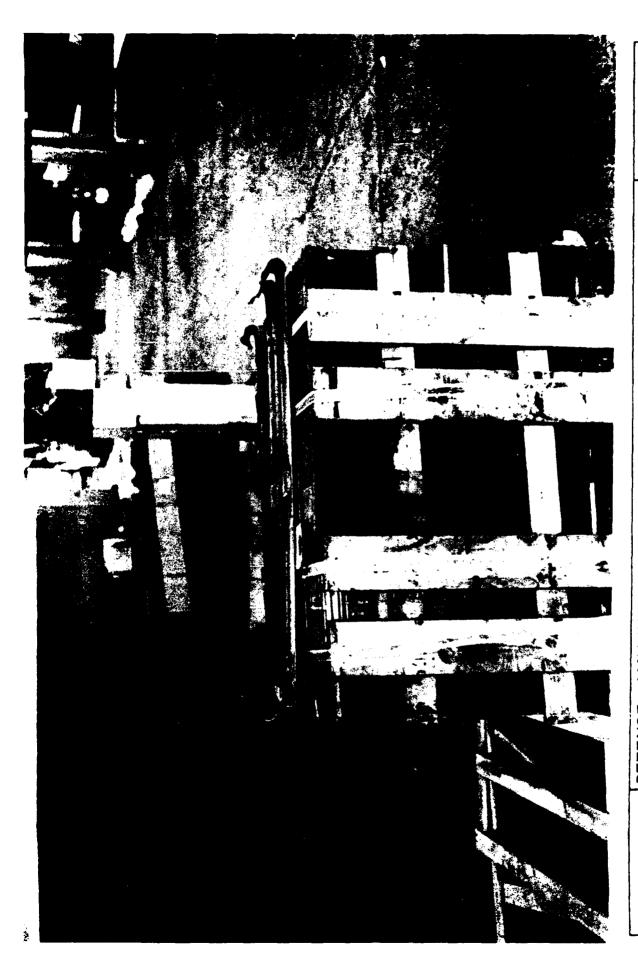
This photo shows the condition of the pallet after it was removed from the Transportation Simulator. Photo 6.

- 1. CONCLUSIONS. The pallet successfully passed both the stacking test and the lateral portion of the transportation simulation. During the second half of the transportation simulation, the test was stopped when the center skid broke loose from the pallet base. The weak point of the pallet that appears to have failed first was at the bend in the posts next to the skids.
- 2. RECOMMENDATIONS. It is recommended that this pallet not be used to transport military loads until design changes are made to the pallet that will enable it to pass the MIL-STD-1660 test criteria. The critical area on the pallet that needs to be modified is the posts that connect the skid to the pallet base. Recommendations for changes to the pallet design would be to use a heavier gauge metal for the posts or add a piece of metal to the inside of the strut to reinforce the bends next to the skids.
